# Success Story

Application: Cooling Tower

Industry Classification: Automotive

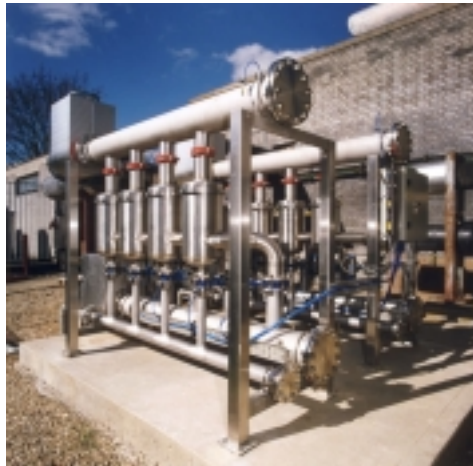
**Solution:** A four pod, System 2000 was installed. The system is filtering the plant's entire flow and is protecting the molding machines and a small chiller plant, plate heat exchanger, and air compressors. Due to plant expansion, and an increase in demand for water, the filter's flow rate has increased.

Flow Rate: 1,200 gpm  
Micron Rating: 125 micron

Filter: System 2000, 4 pod  
Clean DP: 1.5 PSI
