# Success Story

Application: Machine Coolant

Industry Classification: Automotive

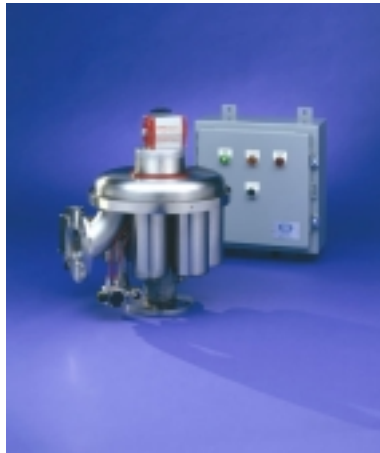
**Solution:** A Phoenix filter combined with a new tank design was installed. Fitted on the tank was a new high pressure, positive displacement pump. The new design significantly reduced much needed floor space. Coolant from the plant's central system is fed into the Phoenix. The discharge from the Phoenix is to the new clean tank where the high pressure pump takes its suction and feeds the machines.
